DOT/FAA/AR-02/128

Paint and Bead Durability Study

March 2003

Final Report

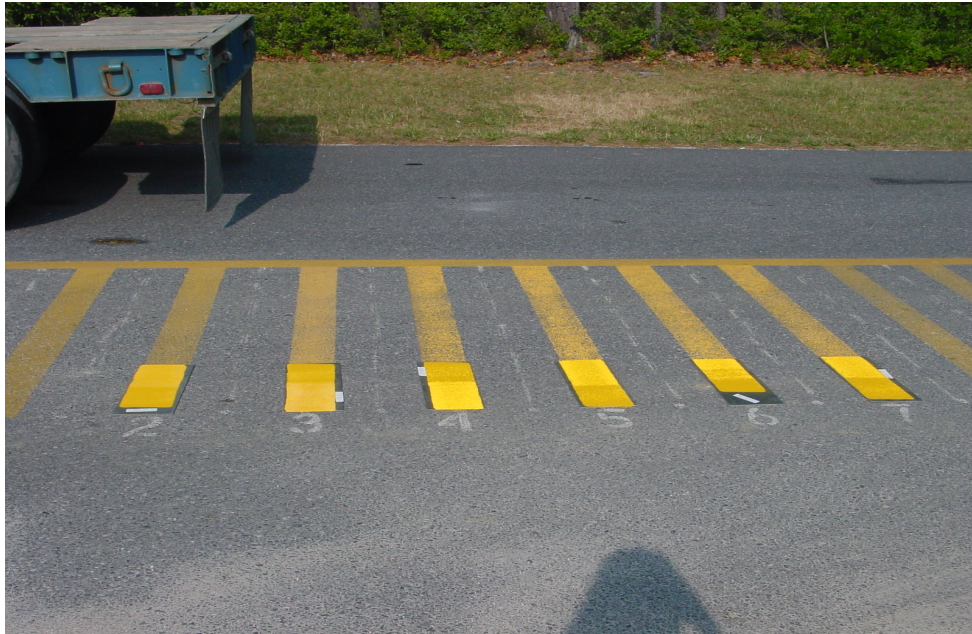
FIGURE 1. YELLOW PAINT WITH Q-PANELS

at the same time of application to compare wear and aging over time. The differences between the appearance of the Q-Panel and pavement markings are due to time. The Q-panels were made at the time of application, June 2001, and the pavement markings are shown in July 2002 (see figures 1, 2, and 3).

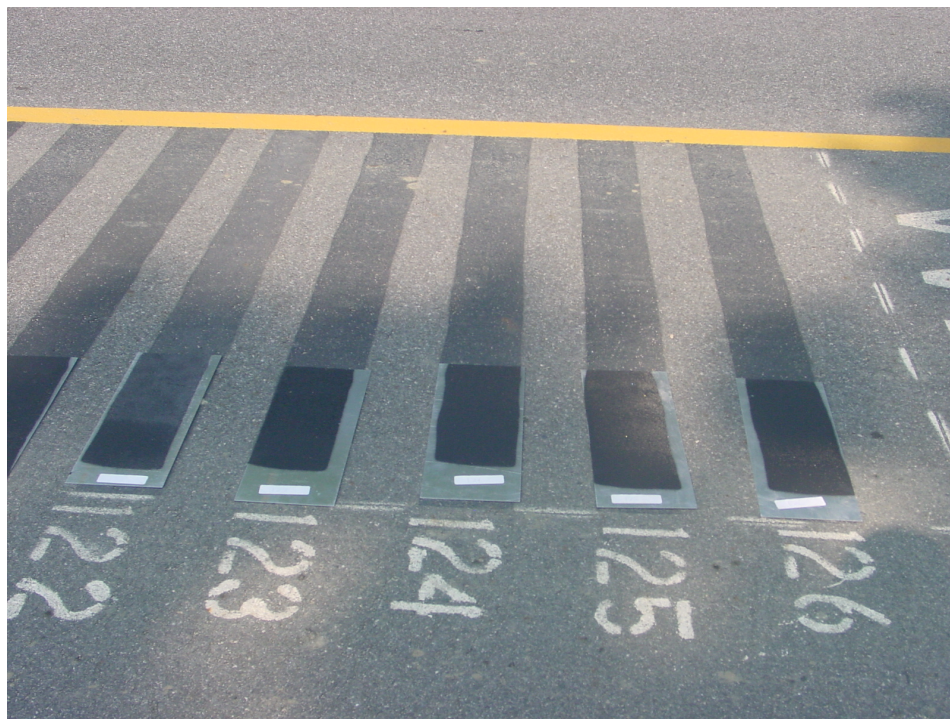
FIGURE 2. BLACK PAINT WITH Q-PANELS

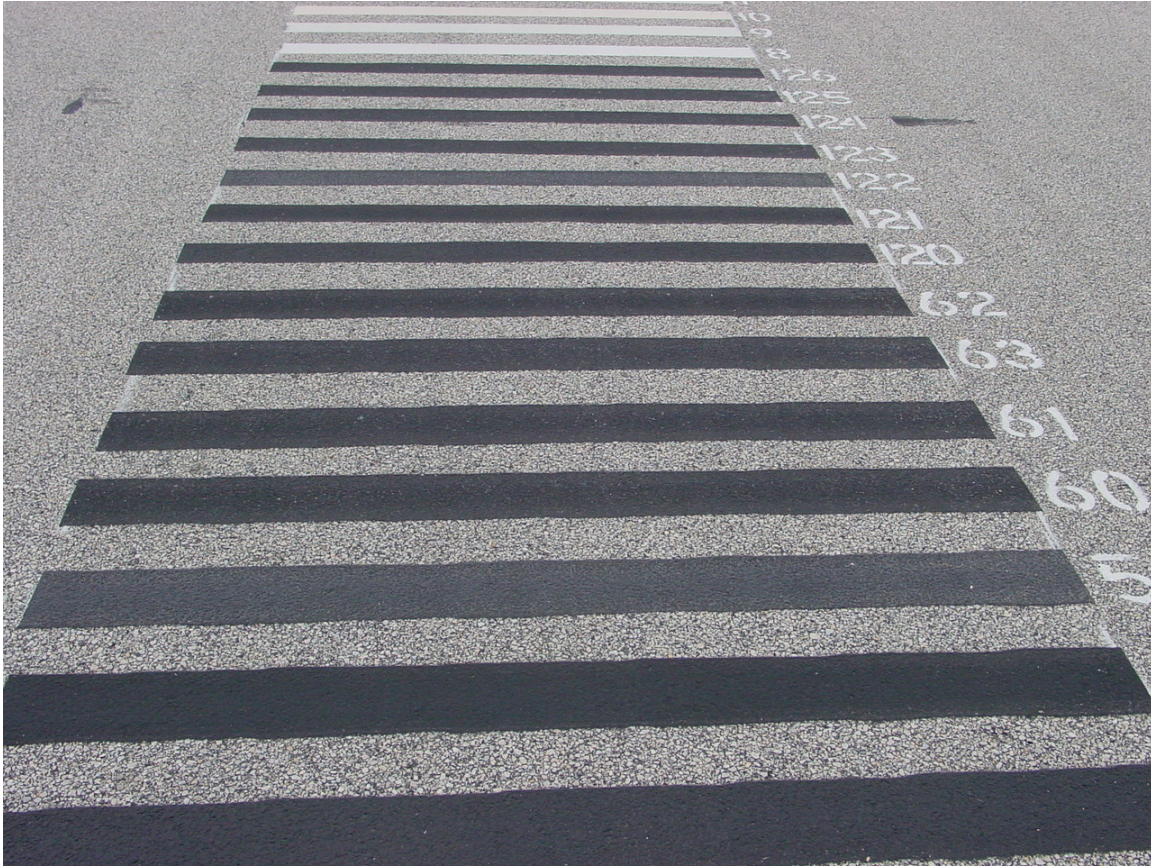
FIGURE 4. BLACK PAINT WITH BEADS

Black paint with beads was applied to simulate accidental application of beads. It was evaluated by painting black markings with and without beads to determine the effects. Figure 4 shows black paint with beads.

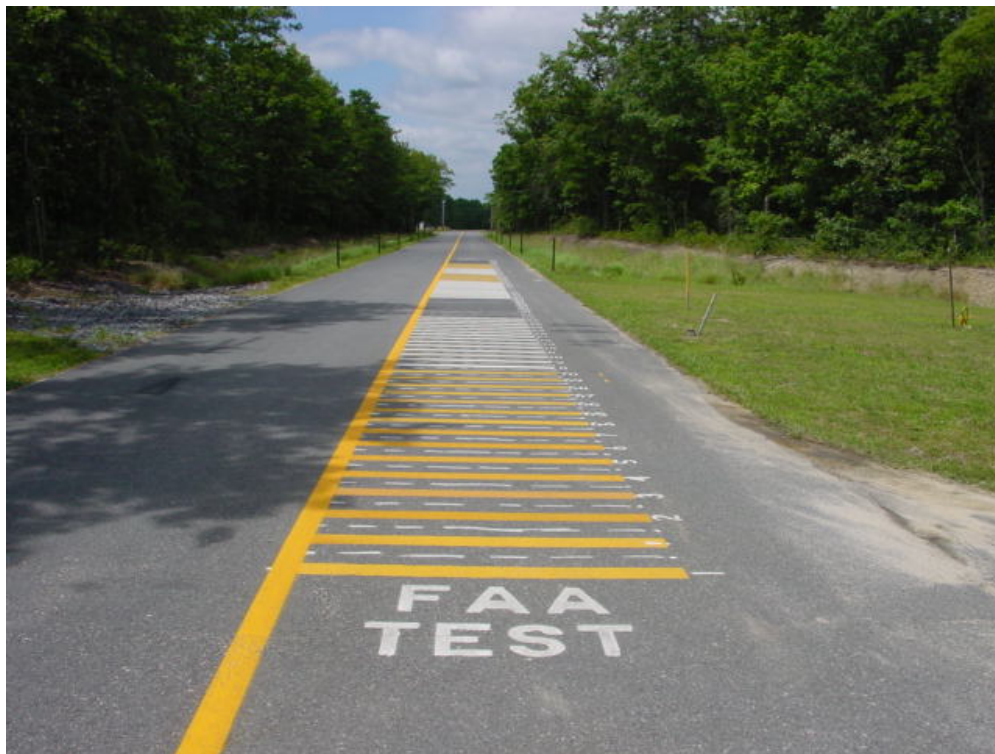
FIGURE 5. LINES AT NEWER HOT-MIX ASPHALT TEST SITE
(Pavement Placed 1999)

The project team took readings with a retro-reflectometer and spectrophotometer every month at the three test marking locations. At the newer hot-mix asphalt test site (pavement placed 1999) located adjacent to building 296 along Pangborn Road, six readings were taken on each line at the beginning, middle, and end of the line and then in the opposite direction at the beginning, middle, and end of the line. Prior to September 11, 2001, the readings at taxiways Hotel and Delta were handled in the same manner. Post September 11, 2001, one reading per line was allowed due to heightened security at the airport. Figures 5, 6, and 7 show the lines at the newer hot-mix asphalt test site, taxiway Hotel, and taxiway Delta.

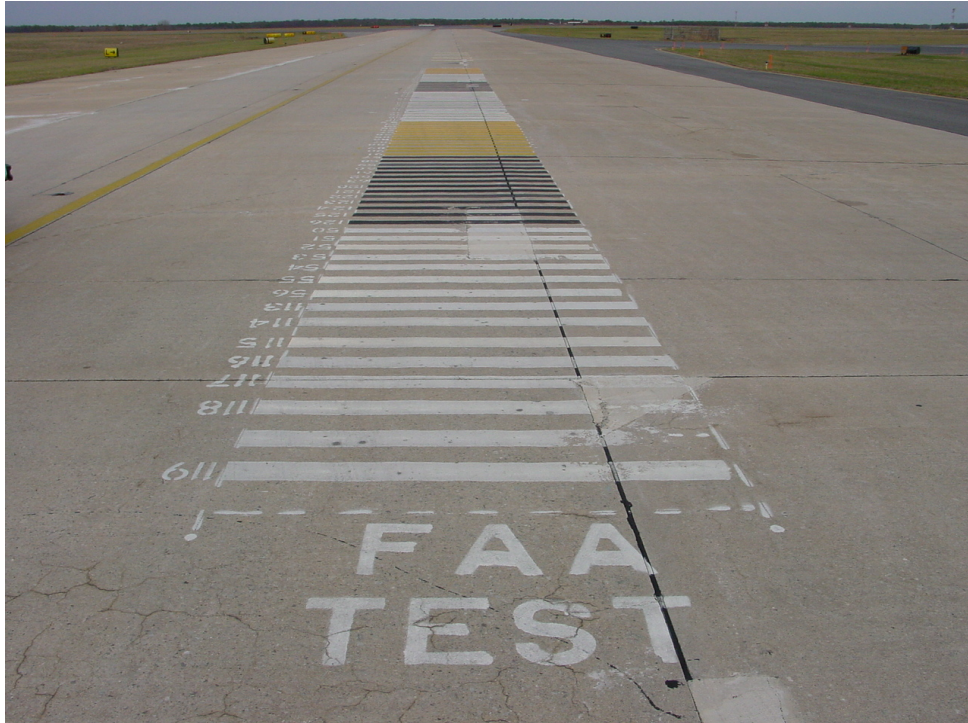
FIGURE 6. LINES AT TAXIWAY HOTEL ON PORTLAND CEMENT CONCRETE

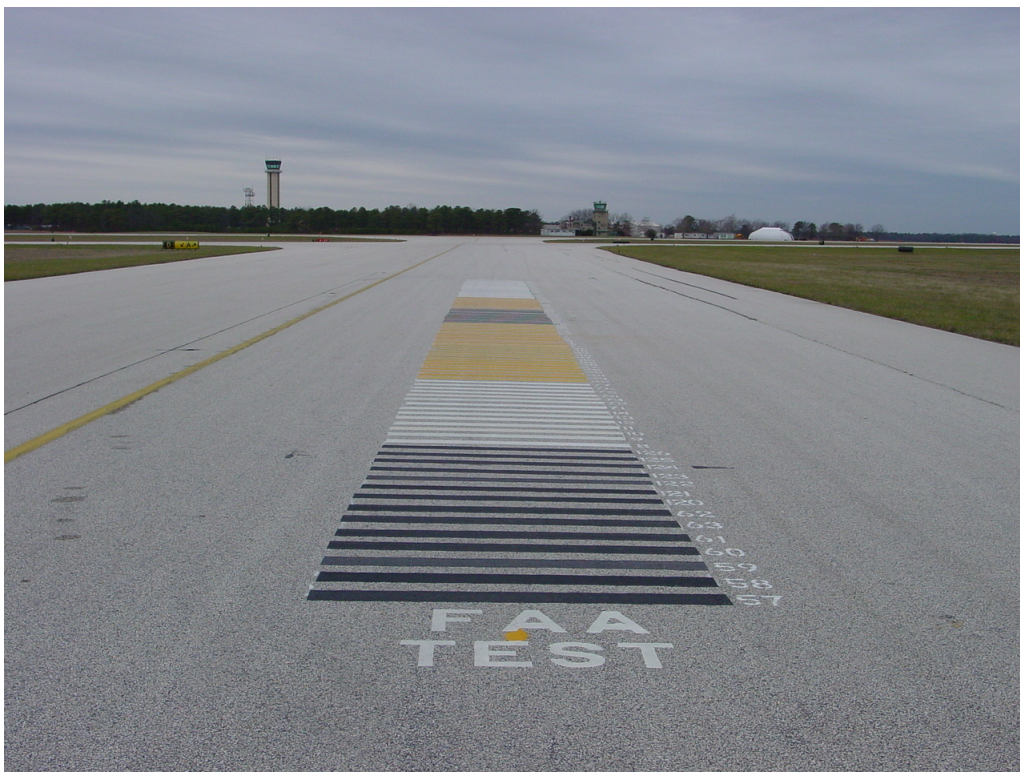
FIGURE 7. LINES AT TAXIWAY DELTA ON OLD HOT-MIX ASPHALT

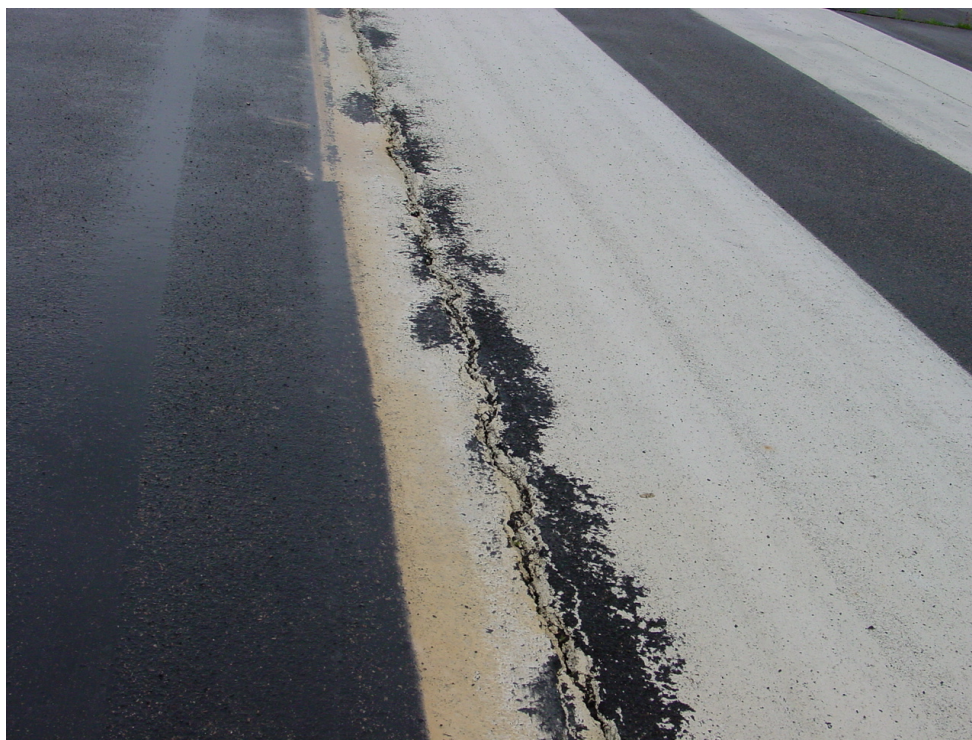
FIGURE 10. YELLOWING OF THE WHITE PAINT AT NEW BEDFORD AIRPORT, NEW BEDFORD, MASSACHUSETTS

The discoloration of the paint due to oil from the asphalt washing over the surface and acid rain was observed at New Bedford Airport in New Bedford, Massachusetts; Worcester Airport in Worcester, Massachusetts; and Lawrence Airport in Lawrence, Massachusetts (see figure 10). At all three locations, the white paint was turning yellow. The paint was also coming up in big sheets because there were at least eight layers of paint already applied at the time of repainting.
